Emergency Response Plan Documentation Report

12th Street Landfill

Plainwell, Michigan

July 2008

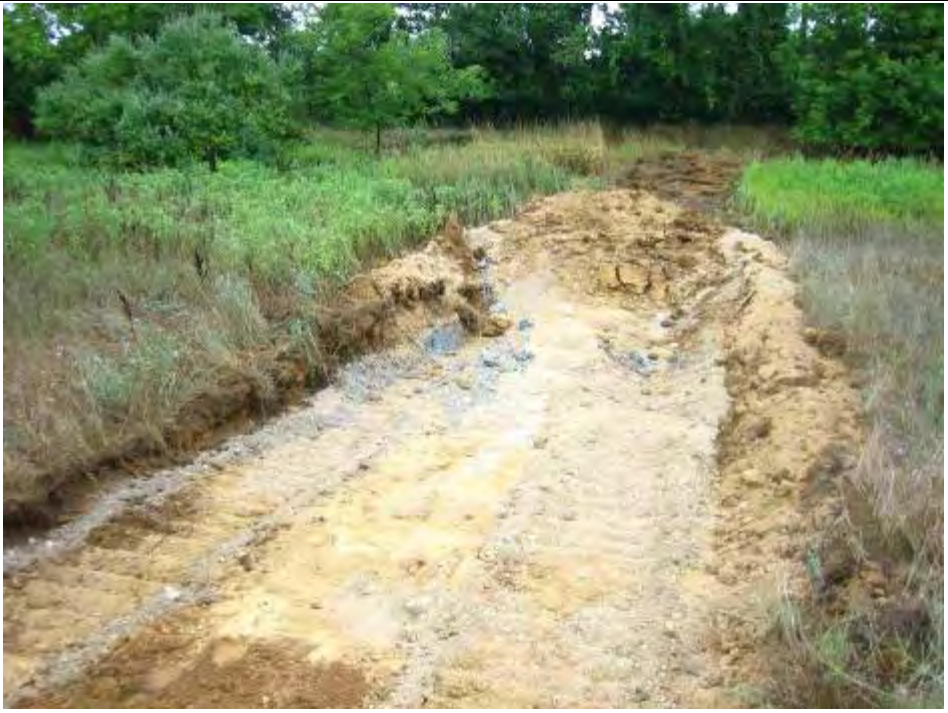
12	8/08/2007		
Description			
Begin construction of containment pad top of 12 th St. Landfill. All residual material (grey seams) left within pad area.

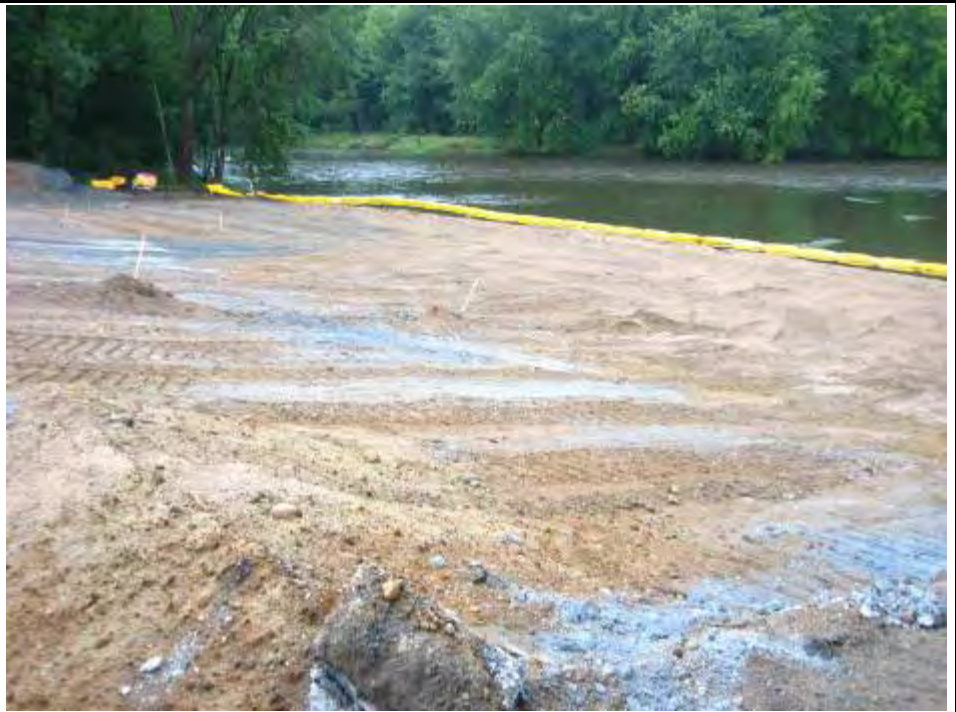
Description East bank of landfill reshaped for access. Any grey residual material removed from bank transferred to containment pad. Material left in place was covered with general fill and will have final cover placed during landfill closure construction			
Photo No. 18	Date 8/21/2007

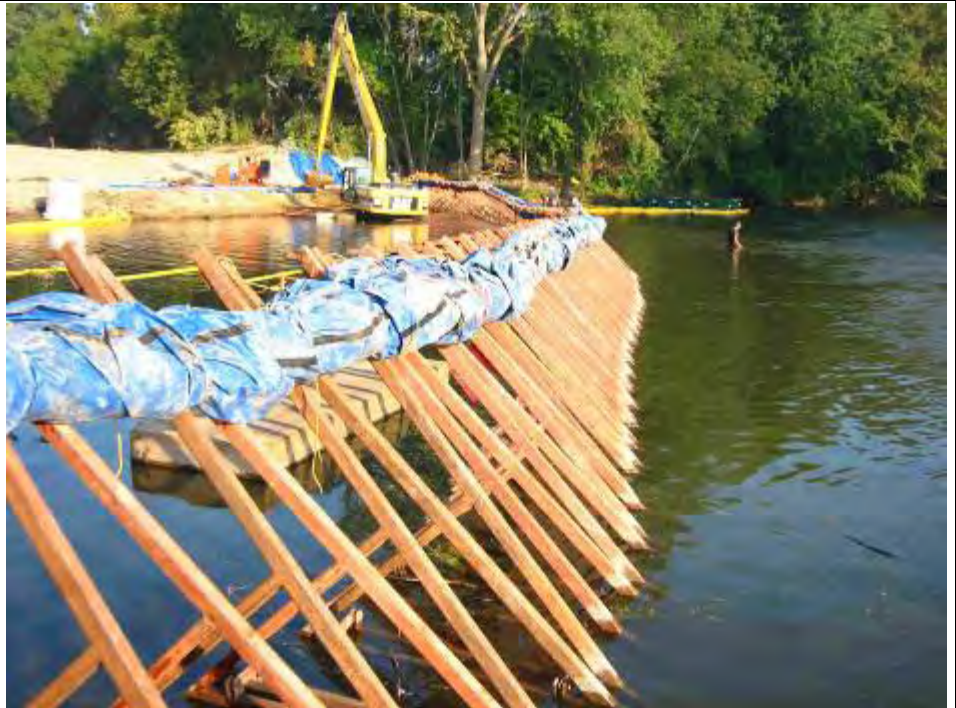
Description Barrier seen in place on port-a-dam skeleton prior to be “rolled down” Placement of fabric delayed due to high flow rates in River			
Photo No. 22	Date 9/05/2007

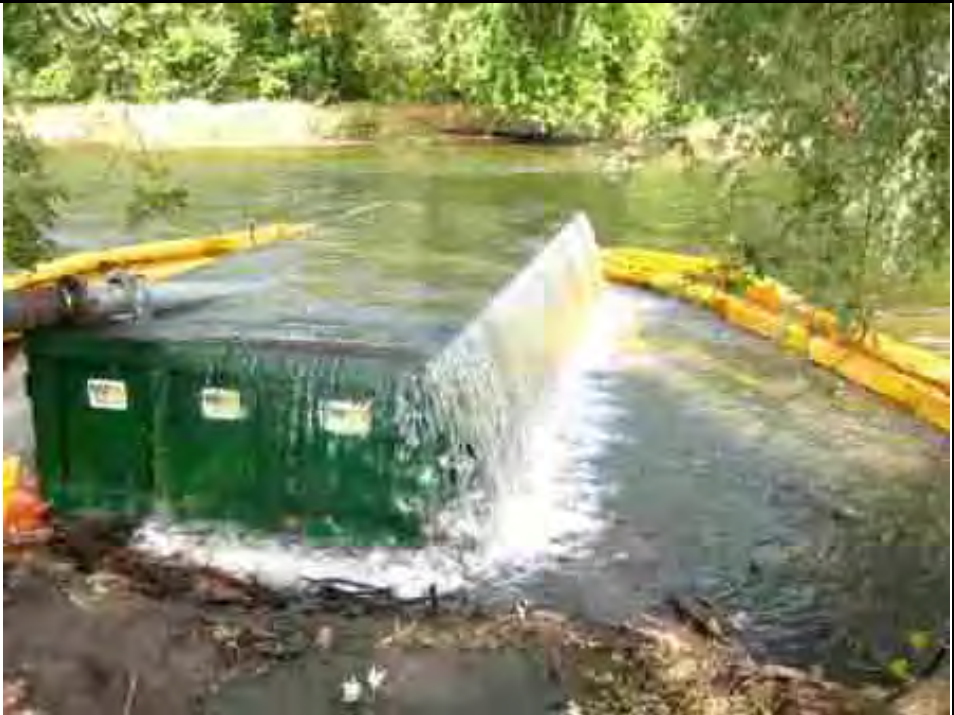
26	9/07/2007		
Description			
Discharge diffuser from pumping down channel. Double silt curtains utilized as secondary containment.

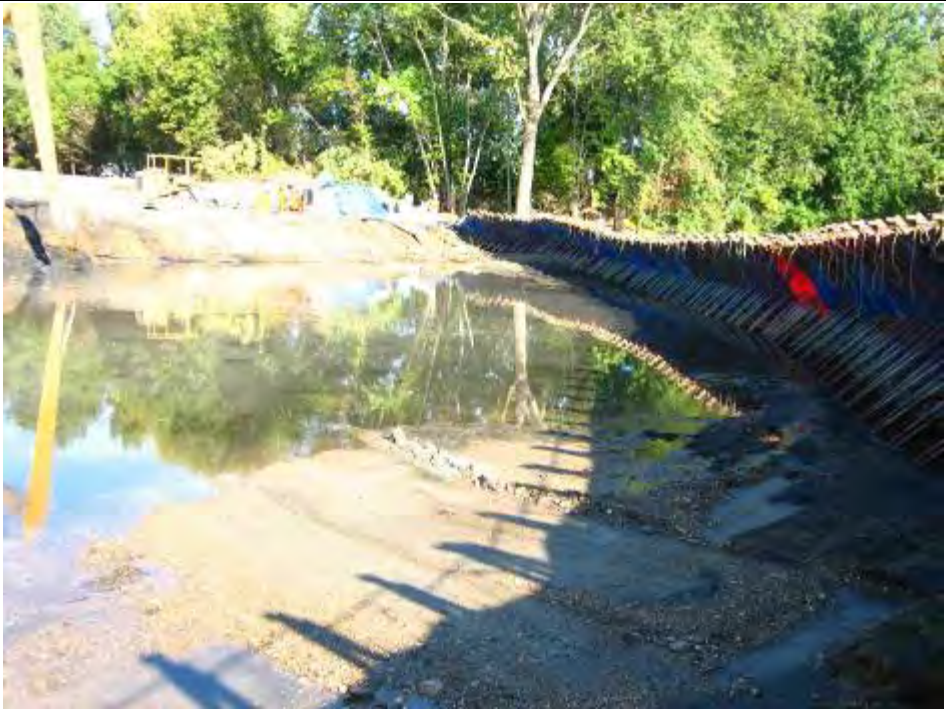
Description View of channel after excavation. Coarse sand and gravel on channel floor.			
Photo No. 30	Date 9/9/2007

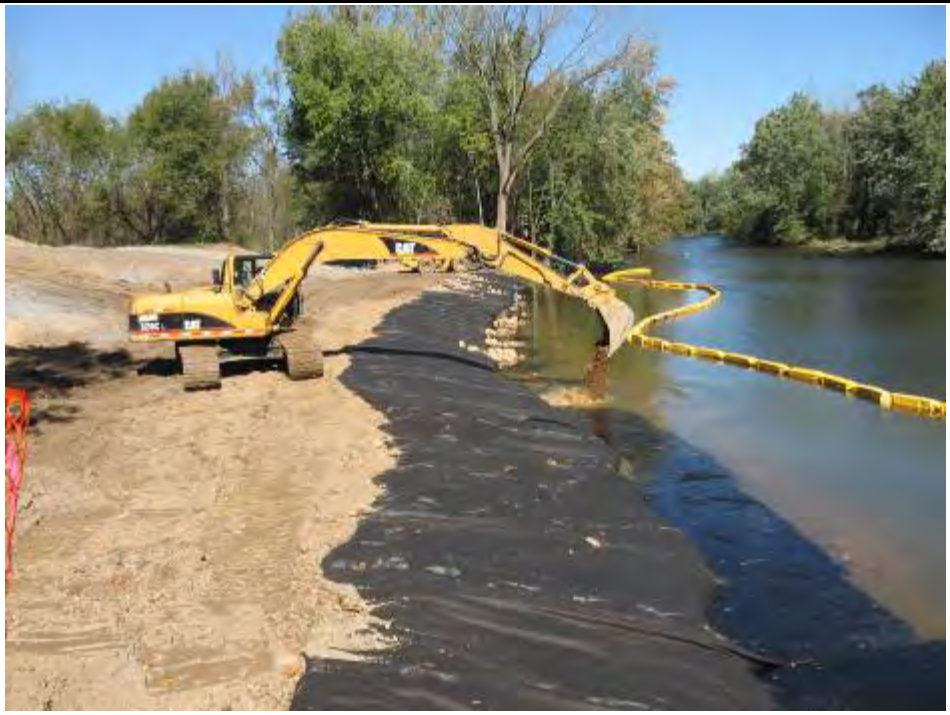
36	10/9/2007		
Description			
Placing stone within key trench at base of bank shoreline over geotextile fabric

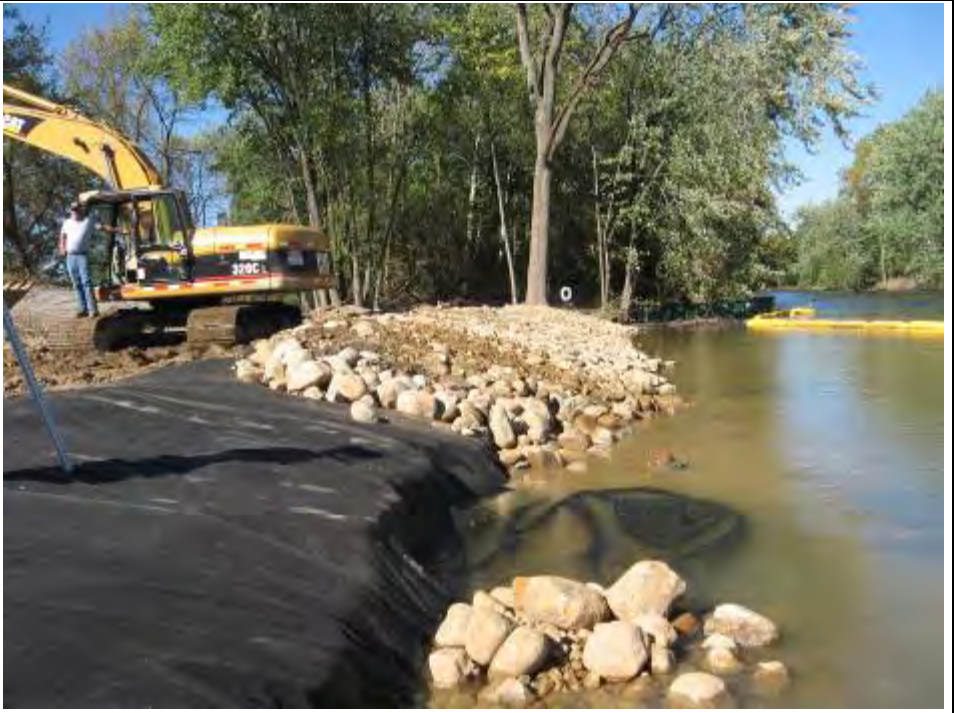
Description Placement of stone over geotextile. Larger stone placed and filled in with smaller.

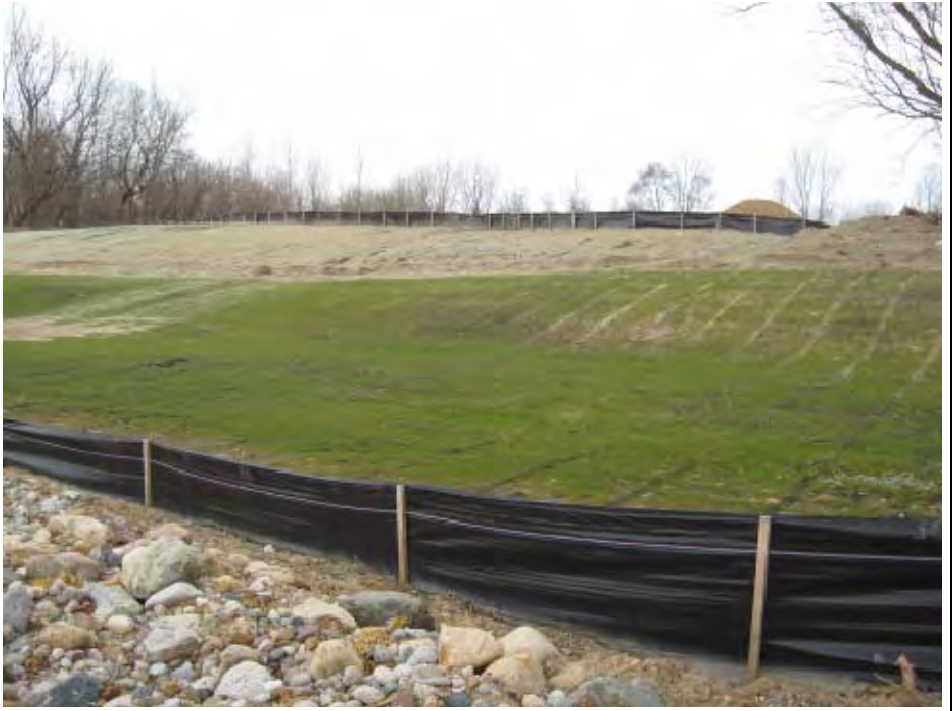
Description East face of landfill with vegetative growth – additional silt fence placed at top of bank			
Photo No. 44	Date 4/10/2008
